The relationship between geology and rock weathering on the rock instability along Mugling-Narayanghat road corridor, Central Nepal Himalaya

Abstract

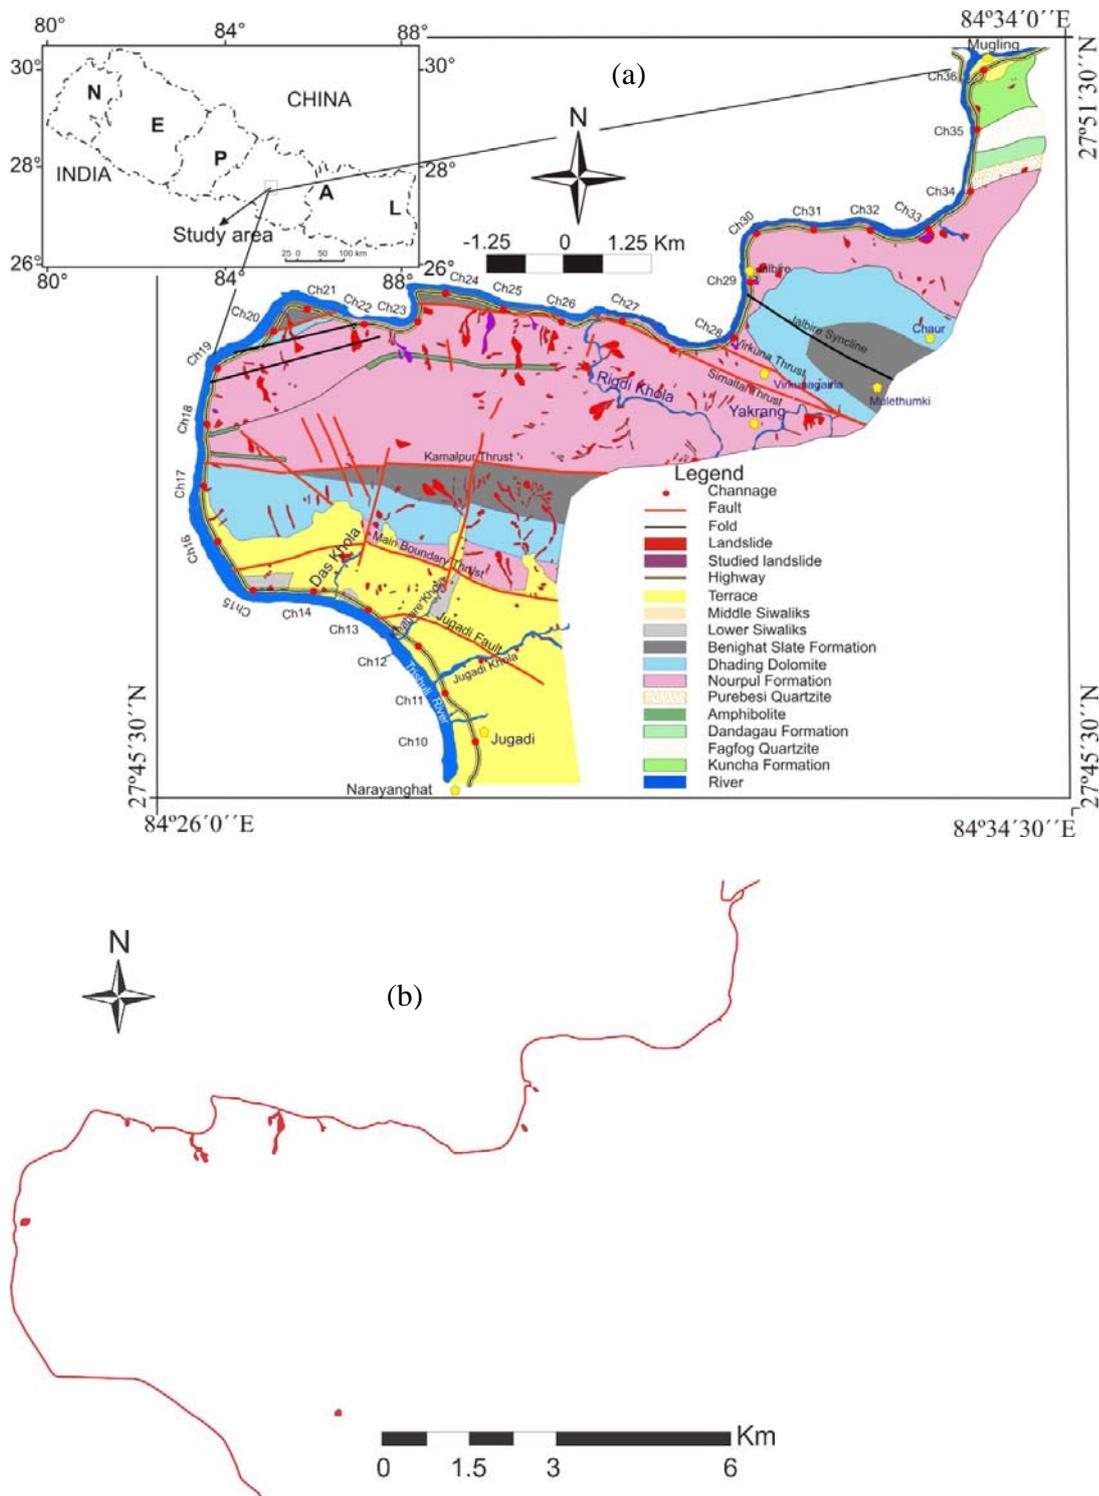
Fig. 1 a Map showing the study area, geological map along with the distribution of landslides, including the landslides selected for detailed investigation, **b** Map showing just the landslides under investigation in this study

Lithology is one of those parameters known to influence landslides in some regions because certain geological conditions accelerate weathering and prepare the rock for mass movements (Goretti 2010). There are numerous associations of mass movements with particular rocks which demonstrate the importance of lithology and mass movements (Sidle et al. 1985). The lithology in Mugling–Narayanghat road section and its surrounding area consists of the rocks belonging to Holocene Terrace deposits, Siwaliks rocks and Lesser Himalayan rocks. The distribution of landslides along different rock formation is shown in Fig. 1a. In order to understand which class in the

The geologic unit in the study area with the most landslides per unit area of exposure is the Amphibolite followed by Nourpul Formation and Benighat Slate Formation (Fig. 11b). The Amphibolite is intruded within the Nourpul Formation (Fig. 1a). The slates, phyllite are highly weathered while amphibolites are highly fractured and jointed. The rocks in the Purebesi Quartzite member and Dhading Dolomite Formation are highly jointed and fractured making them vulnerable to rock fall and rockslide. This finding agrees with the general agreement of Gerrard (1994) according to whom phyllite rocks are the most susceptible to landsliding followed by shales, schists, poorly cemented sandstones, gneiss, granites and quartzite.

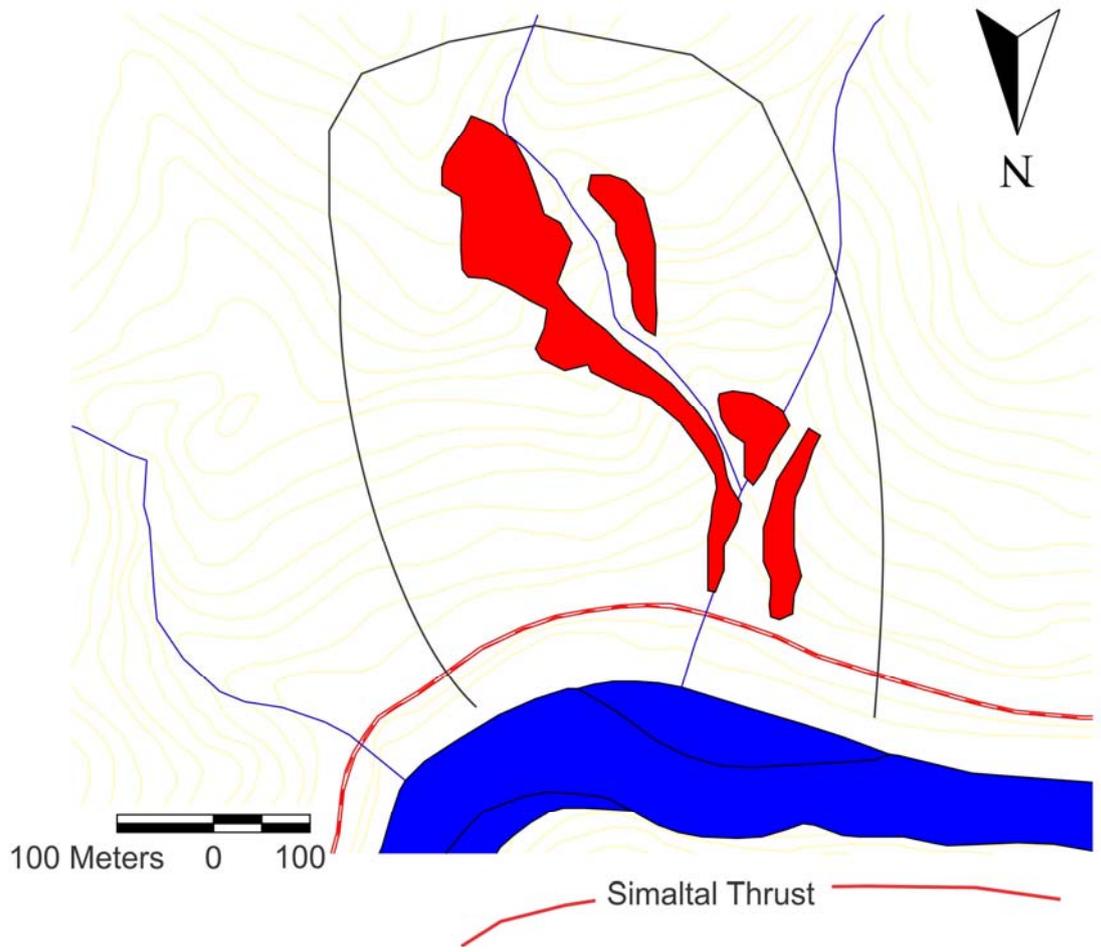
Fig. 3 Plan view of the Maure Khola landslide. Red polygons indicating the active landslides, blue boundary indicates the gravitationally deformed surface

Most part of the Mguling–Narayanghat road passes through the gravitationally deformed zones. Maure Khola landslide is one of them. It is very active landslips in the Mugling– Narayanghat road section (Fig. 3). The rock debris generated by the landslides was mobilized into a disastrous debris flow in 2006 summer and damaged the

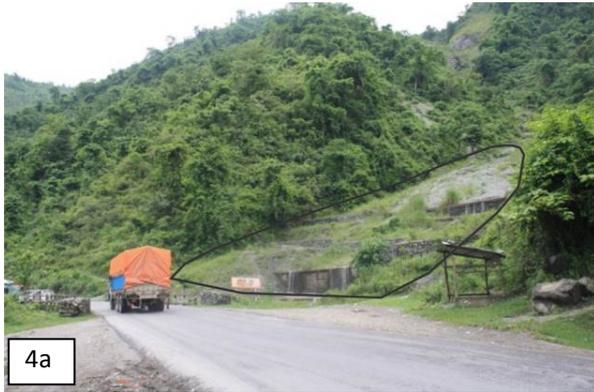
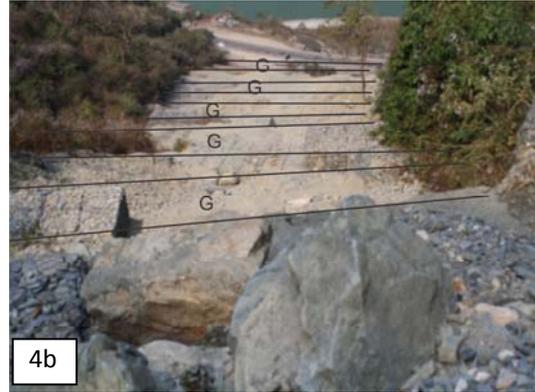
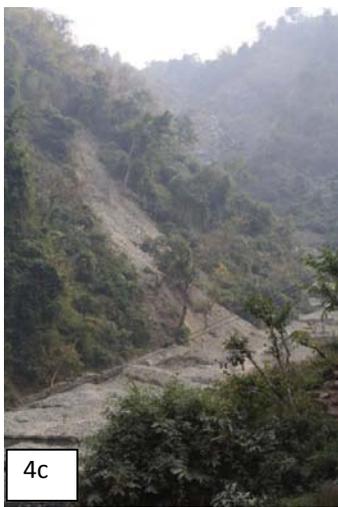
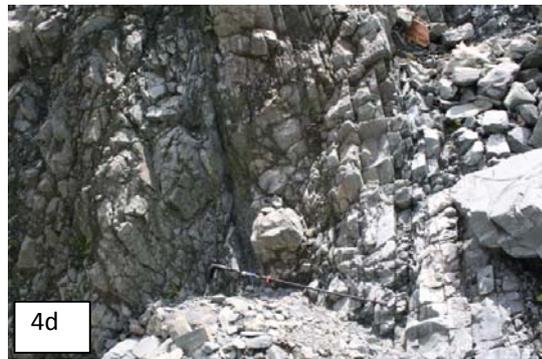
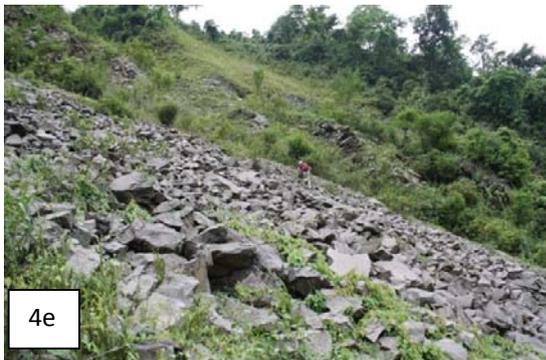
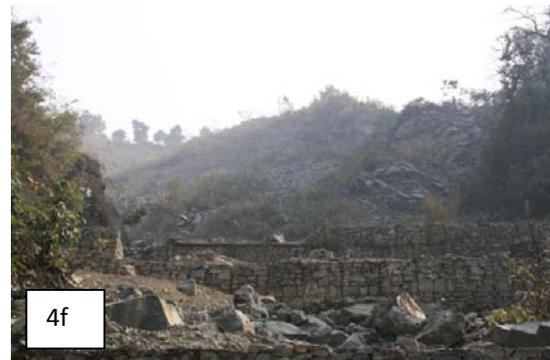
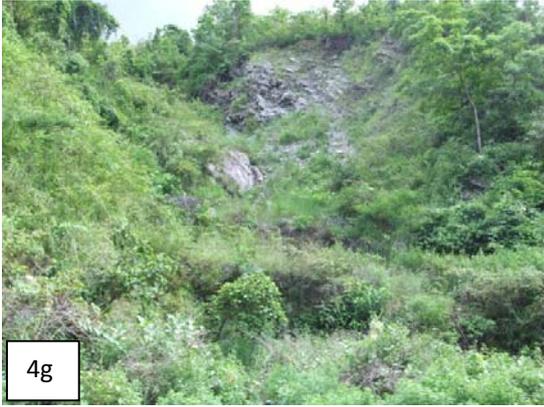
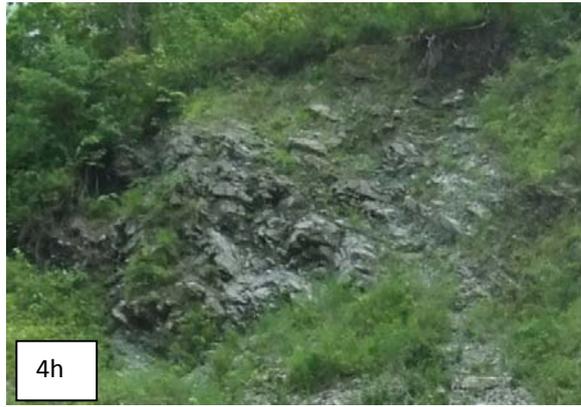
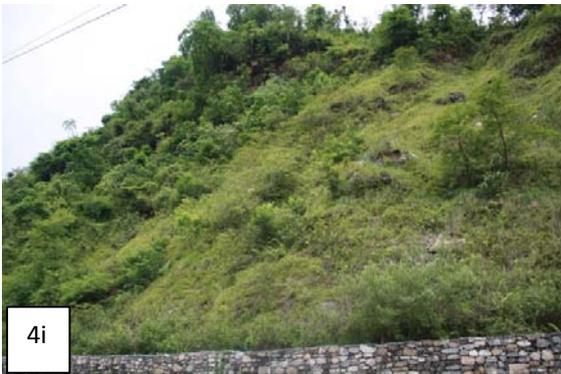
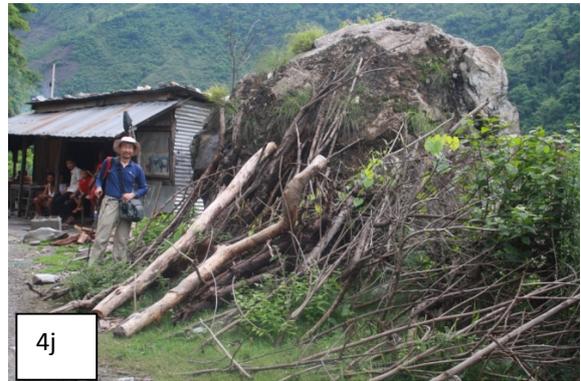
Fig.4: Continued

Fig. 4 (a) The debris fan {indicated by black line} in the bottom part of the landslide just above the highway. (b) Several gabion walls {indicated by black box (G)} used to control the debris. (c) Debris observed in the channel at the central part of the channel and small debris slide in the valley walls. (d) Moderately weathered, highly fractured amphibolites and pink quartzite showing rock toppling. (e) Channel covered by several big boulders of amphibolites. (f) The upper part of the landslide consisting of rock topple is dominated by quartzite and slate. (g) General view of the landslide at Ch 23.760 km. (h) Fractured and decomposed rocks observed in the landslide of Ch 23.760. (i) Road section showing the steep cliff at Ghumaune, where rock failure occurred during the monsoon of 2006. (j) Large boulder of dolomite formed by the rock failure in Ghumaune during the monsoon of 2006 lying along the road side

The lower part of the landslide body is mostly covered by thick deposit of debris that was derived from the main landslide as well as from the sides of the landslide (Fig. 4a). It is mainly the depositional zone of the landslide. The thickness of the debris is about 5 m, and it covers the entire valley. The volume of this debris is about 60,268 m³. The debris consists of materials ranging in size from boulders to clay. The channel slope is 22.5° and the width of the channel is > 30m. The main material bordering the debris is the terrace deposits. Dense forest is observed along the valley wall. No water is observed along the channel in this part; however, the water is present in the channel below the road. Water here flows as sub-surface water flow. Several gabion walls have been constructed here to protect the road and the bridge downstream (Fig. 4b). The first gabion wall is constructed at a distance of 15 m from the road section, and others are located at a distance of 10–15 m from each other (Fig. 4b).

The central part of the landslide mainly consists of debris deposits in the channel while small debris slides and rockslides occur in the valley walls (Fig. 4c). Here, highly fractured, moderately weathered black slates with some quartz veins are observed. Moderately weathered greenish phyllite is observed above the black slate. The groundwater is high in this part. Moderately weathered, highly fractured pink quartzite with phyllite parting is observed about 10 m upstream from the greenish phyllite. Here, rock toppling is observed (Fig. 4d). The attitude of the foliation plane is $270^{\circ}/74^{\circ}\text{N}$ while that of the joints are $J1=350^{\circ}/75^{\circ}\text{NE}$, $J2=145^{\circ}/57^{\circ}\text{SW}$. The joint spacing is from few cm to 10 cm. These joints are responsible for the rockslide in this part. Massive amphibolite is observed above this. This amphibolite is also highly fractured and jointed. Many big boulders of amphibolite are observed in the channel (Fig. 4e). The fractured and jointed nature of the amphibolite is the reason for the presence of these boulders. There are many slickensides in the rocks showing some kind of movement. Many gabion walls have been constructed here to stop the debris flow. Rock topples are observed in most of the rock exposure.

The main landslide is located in the upper reach of the slope (Fig. 4f). Here, mainly rock toppling is observed in the slate (Fig. 4f) at the western part as well as in the quartzite lying in the southeastern part (Fig. 4f). Slate show moderate weathering, while quartzite

The rock types encountered at the present landslide consist of interbedded quartzite, phyllites and slate of the Nourpul Formation. The quartzite is highly jointed and fractured, and the phyllites are weathered and crushed into soils. On the lower left side of the landslide, quartzite is intensely fractured, separating the outcrops into the number of unstable blocks. Phyllite is exposed on the right side, which is highly weathered and behaves either like a soil or unusually fractured and jointed when it is fresh. In the lower part, soils are sandy gravel with lots of fines and some boulders and blocks, and the thickness varies from <1 m to >5 m. The attitude of the foliation in undisturbed outcrop is dominantly $270^\circ/72^\circ\text{NW}$, and the attitude of the major joint is $220^\circ/63^\circ\text{NW}$. Some folded structures are also seen on the slate and phyllite. Huge quartzite boulder is observed in the lower part of the landslide (Fig. 4g). The upper part of the landslide is covered by 2–3 m

thick soil. Below this, highly weathered rocks are observed, and the lower part of the landslide is consisting of decomposed rocks and debris deposits (Fig. 4h). Although some engineering structures are constructed for the protection of the slope failure to some extent (Fig. 4g), the landslide still seems active and highly hazardous for the villages located up slope and road below.

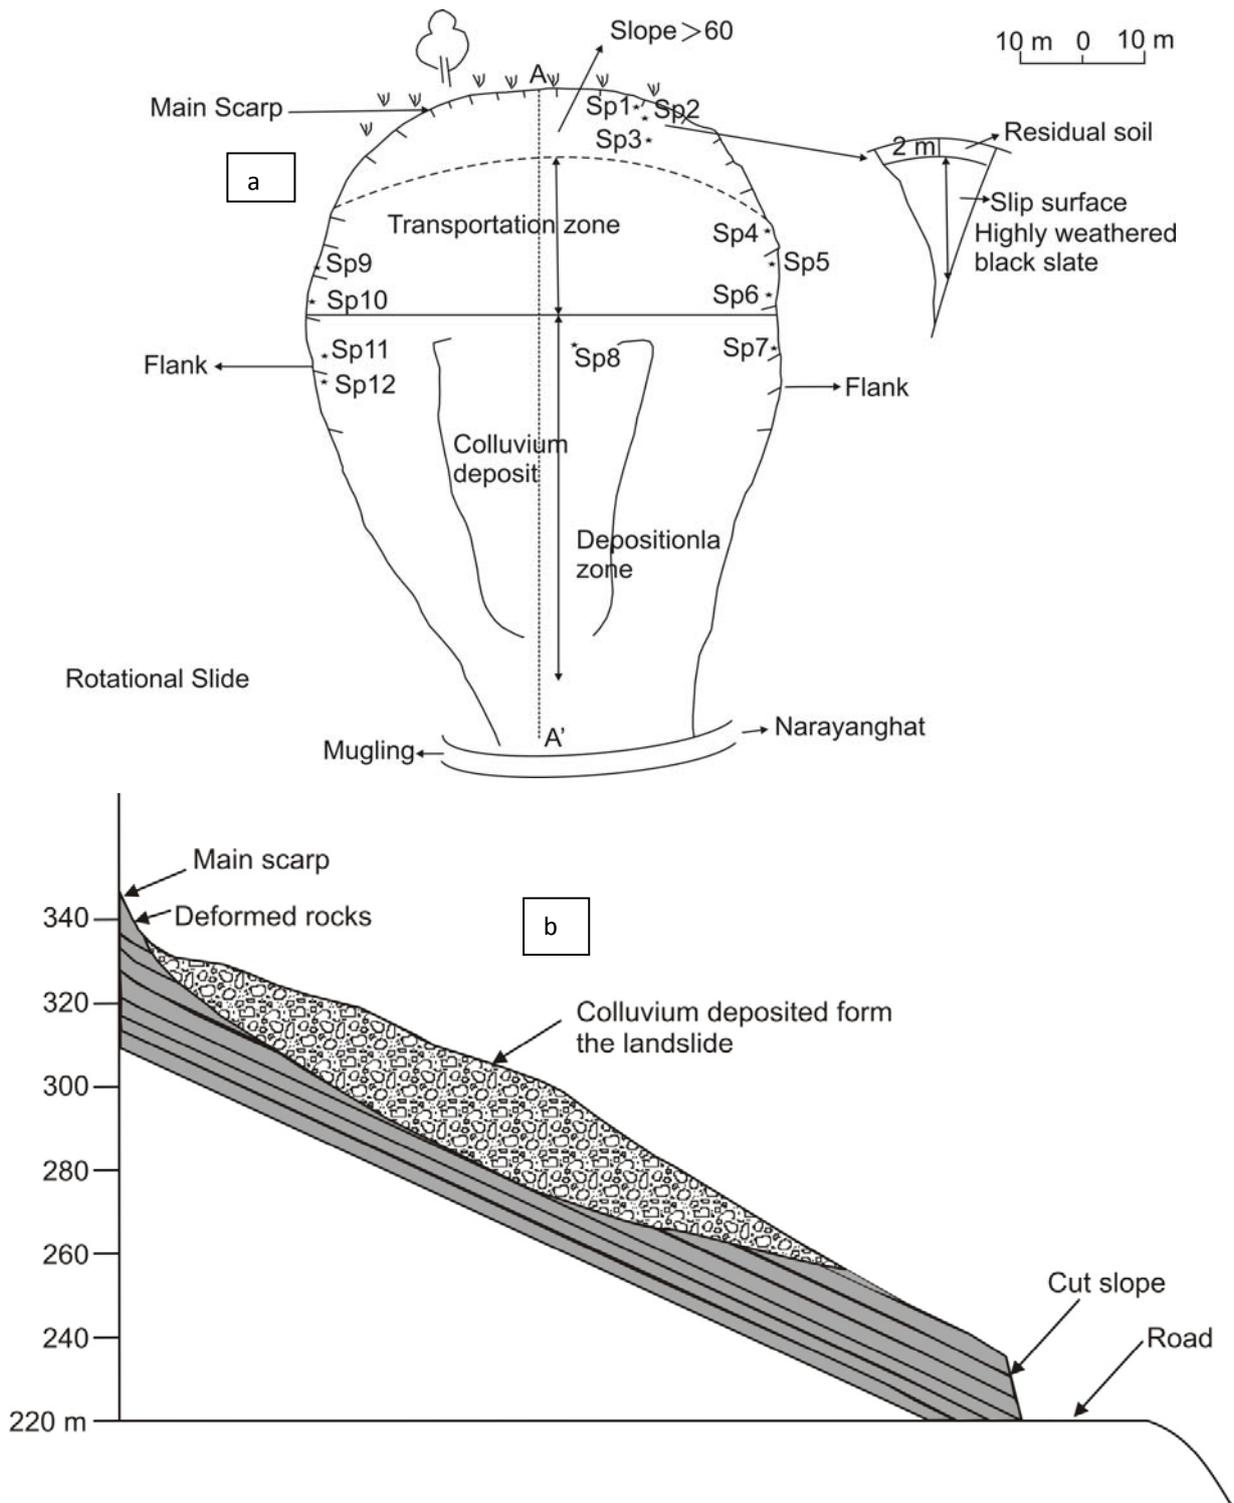
Fig. 5: (a) Detailed view of the landslide. (b) Cross-section along A-A'

This landslide is mainly divided into 3 parts (Fig. 5a, b), source area, transportation zone and depositional zone. The source area, from where all the debris is derived, is located at an altitude of 385 m. The top 2 m is covered by residual soil. Here, the main scarp of the landslide is observed. The slope of the main scarp is 60°. Severely to completely weathered, highly crumbled slate and phyllite are observed here. Only the quartz veins present in the rocks seems to be in good condition. The sliding surface can be seen here. As the rocks are highly deformed here, the attitude of the foliation plane cannot be obtained. However, the rocks are dipping towards north.

Below the zone of source area, transportation zone lies (Fig. 5a, b). Here, the rocks are moderately to severely weathered. It is rather steep zone with only thin deposit of colluvial materials. Rocks are observed at the flank of the landslide, and these are highly deformed. The undisturbed outcrops dip parallel to the hill slope with an attitude of 190°/55°W.

The lower portion of the landslide is mostly covered by thick deposit of debris material (Fig. 5a). These debris are derived from the upper part of the landslide. This is the zone of deposition. Here, no rock exposure is found. This landslide does not contain any stream, and hence, there is no any role of running water. The landslide is mainly caused by the weathering of rocks.

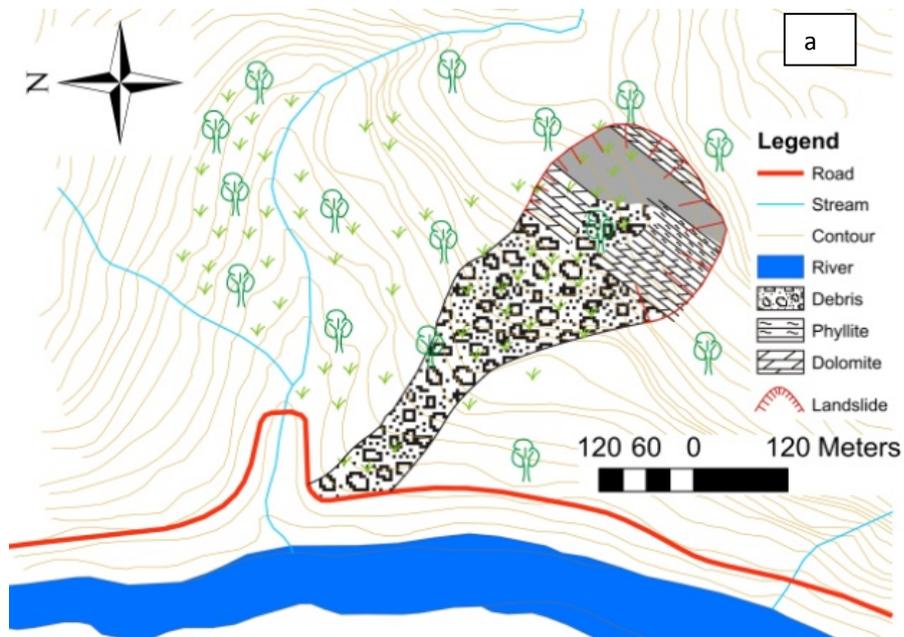
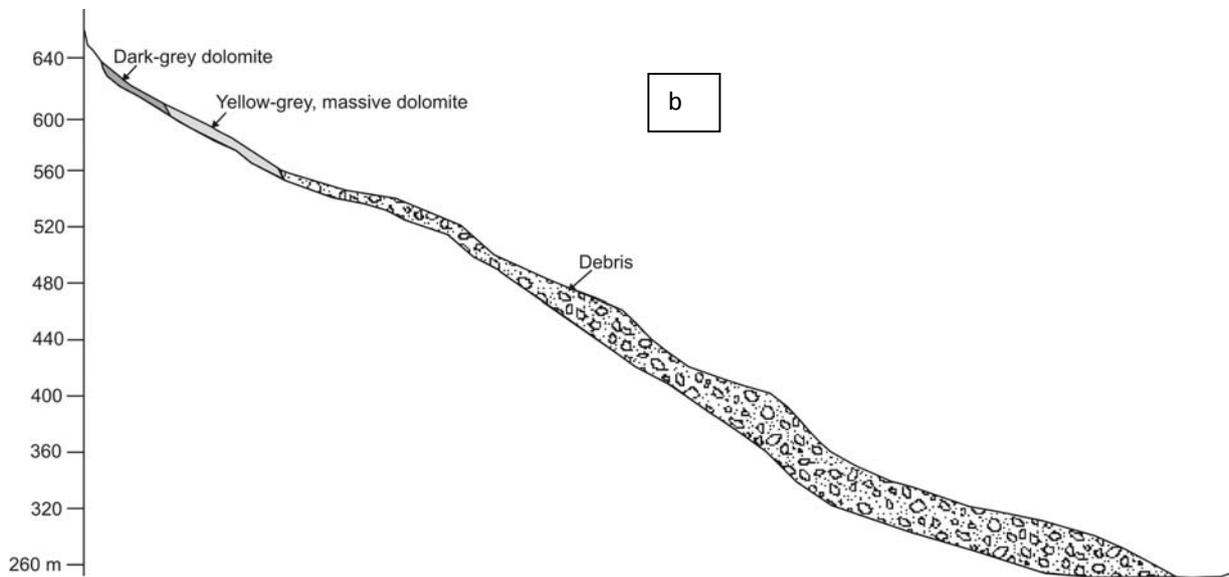
Fig. 6: (a) Plan view of the Jalbire landslide. (b) Schematic cross-section of the Jalbire landslide

The main scar of the Jalbire landslide is located about at an altitude of 640 m. Here, rock fall in the dolomite occurred, which along with the colluviums and residual soil covering the down-slope flowed downhill as a debris flow killing 4 peoples and destroying several houses. The XRD analysis of the collected rock samples from the landslide zone indicated that they are fresh and lack any clay minerals. The main minerals observed at the rock outcrop consist of mainly dolomite, with some quartz and minor amount of mica minerals. The steep upper slope, followed by the jointed rock mass, the dip direction of the beds and the rainfall all combined to generate the rock fall at the upslope and debris flow down-slope at Jalbire. Here, the rock weathering is not affective in the formation of the landslide.

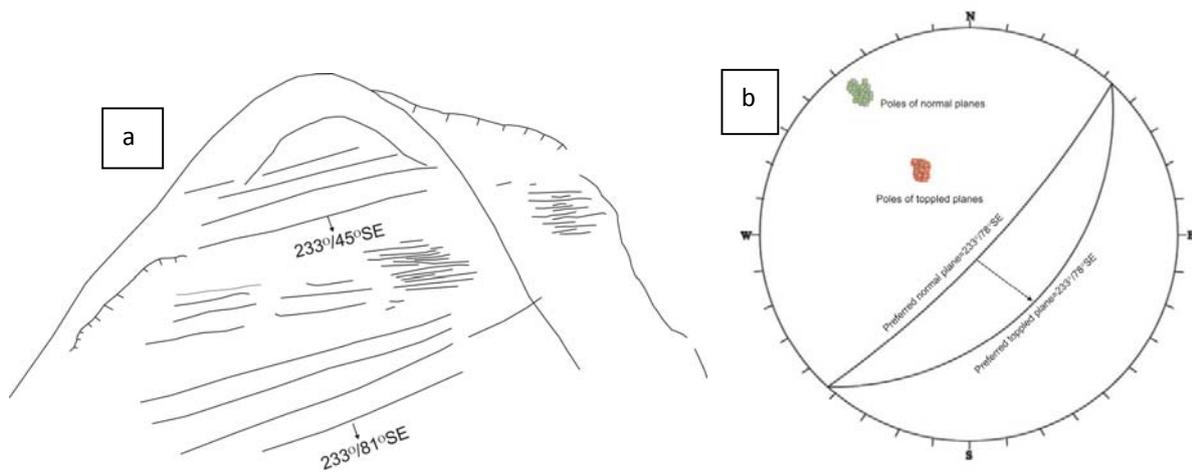
Fig.7: (a) Sketch showing the rock topple at Kalikholagau (b) Serigraphic projection of the poles of the normal beds as well as the toppled beds and the normal and toppled planes.

The outcrop is dominated by slightly weathered slate and few quartzites. The attitude of foliation plane at the lower slope is $233^{\circ}/78^{\circ}\text{SE}$, while that at the upper slope is $233^{\circ}/45^{\circ}\text{SE}$ (Fig. 7a). The rocks are well bedded, and the thickness of the bed ranges from 5 cm to 30 cm. The rock is light grey and is very hard. The dip amount of the foliation plane decreases as the altitude increases, due to toppling. The opening of cracks between the overlying rocks and the rocks below is few cm. Also, it is seen that the rocks are dipping away from the slope, but due to the higher amount of dip angle of the rocks, they are toppled in the upper slope.

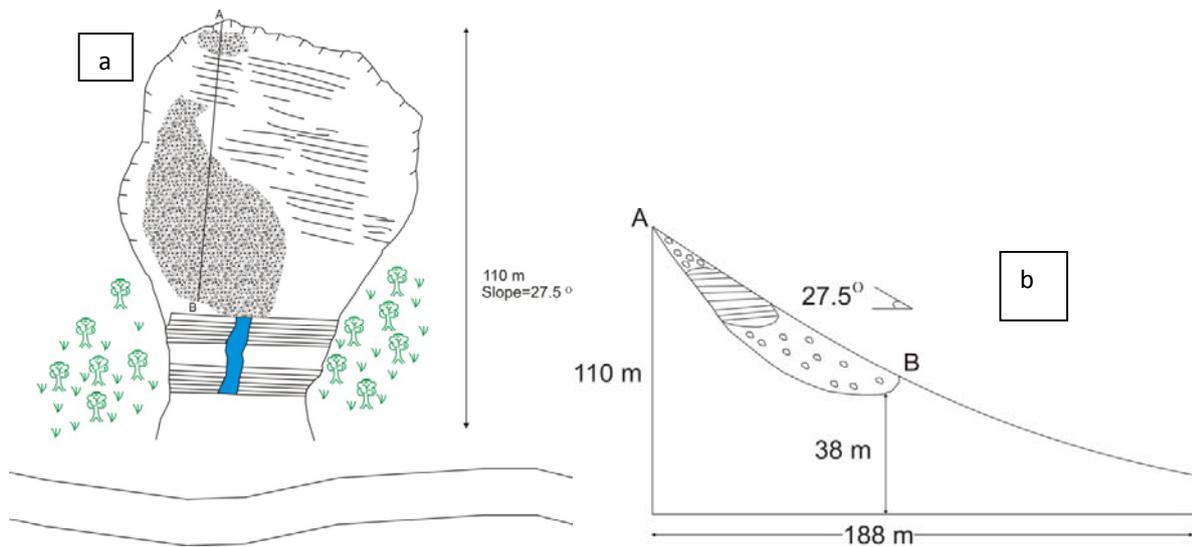
Fig. 8: (a) Landslide observed at Ch 28 km, (b) Cross-section along AB.

The lithological units comprising the landslide at Ch28 are from the Nourpul Formation and consist mainly quartzite, phyllites and some carbonate beds. The rocks are fresh to highly weathered and are intensely fractured, jointed and deformed. Large amount of quartz, mica minerals and some feldspar constitute the main mineralogy of the collected rock and soil sample from the landslide zone. The collected rock and soil samples consist of chlorite and mica as the main clay mineral. In the formation of this landslide, both the chemical weathering and physical weathering have played a significant role. The occurrence of weathered rocks, thick debris cover in the dip slope followed by the presence of numerous joints and fractures and heavy rainfall all combined together to generate this landslide.

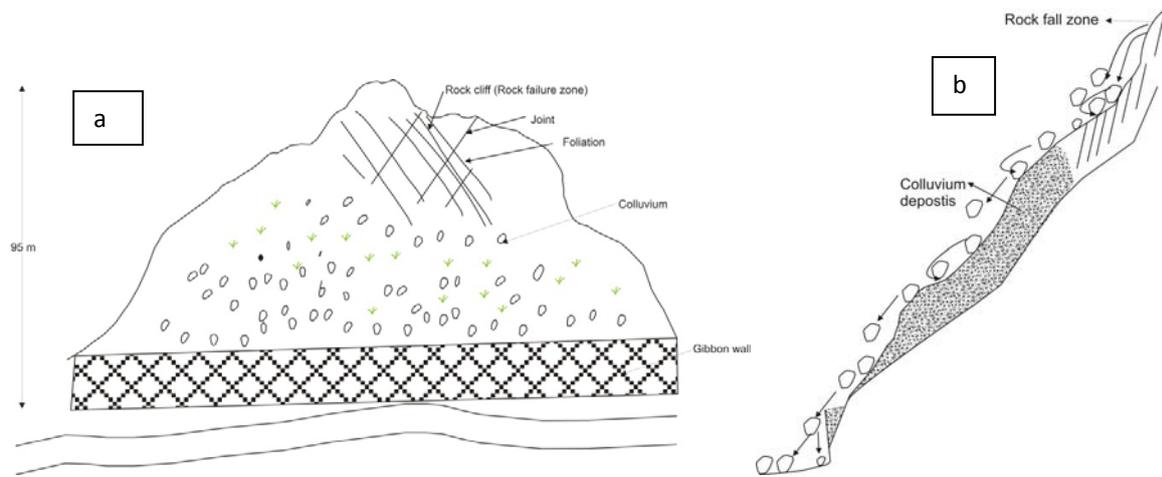
Fig. 9: (a) Sketch showing the rock fall zone near Ghumaune of 2006, (b) Cross-section of the rock fall area.

The outcrop comprising the Ghumaune rockfall are mainly dolomite and dolomitic quartzite with some phyllite partings belonging to Nurpul Formation of the Nawakot Complex. Nearly vertical cliff persists in the vicinity of the landslides. From the thin section and XRD analysis of the collected rock samples, it is seen that quartz, dolomite and mica minerals constitute the main mineralogy with some minor amount of feldspar. No clay minerals are found in the rocks sample collected from this landslide. Even though the phyllite seems to be weathered, no clay minerals could be detected. The high dip amount and highly jointed nature of the dolomite, followed by very steep slope (nearly vertical), are combined together to generate the present rock fall.

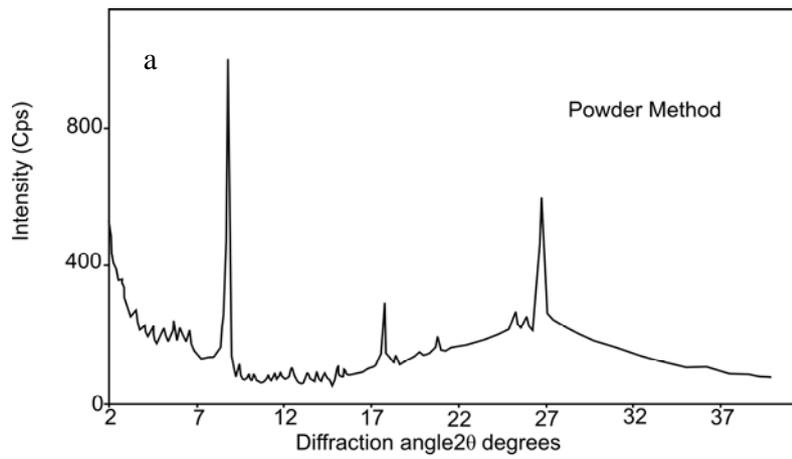
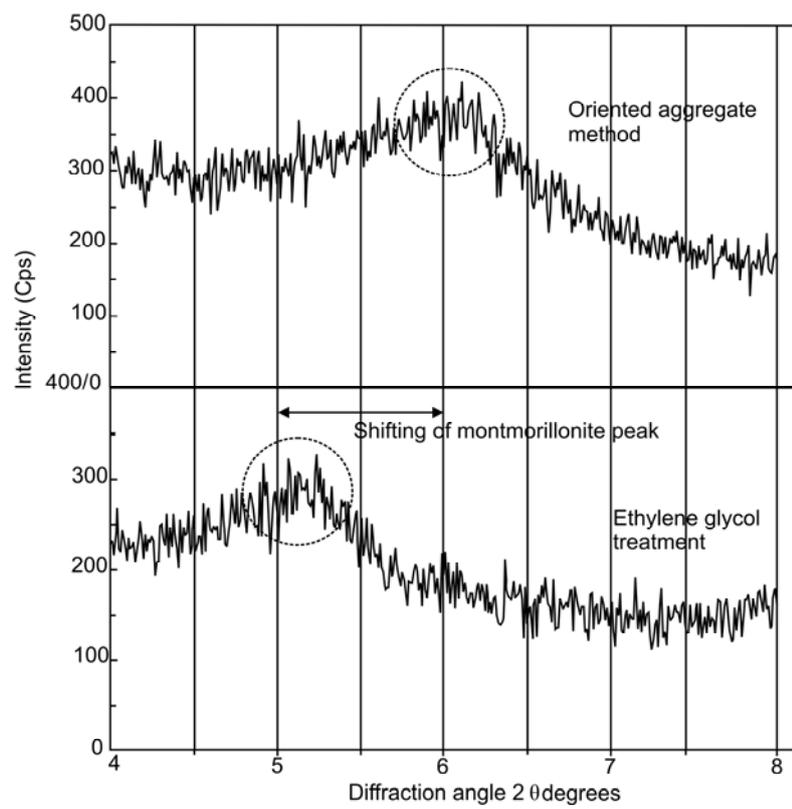
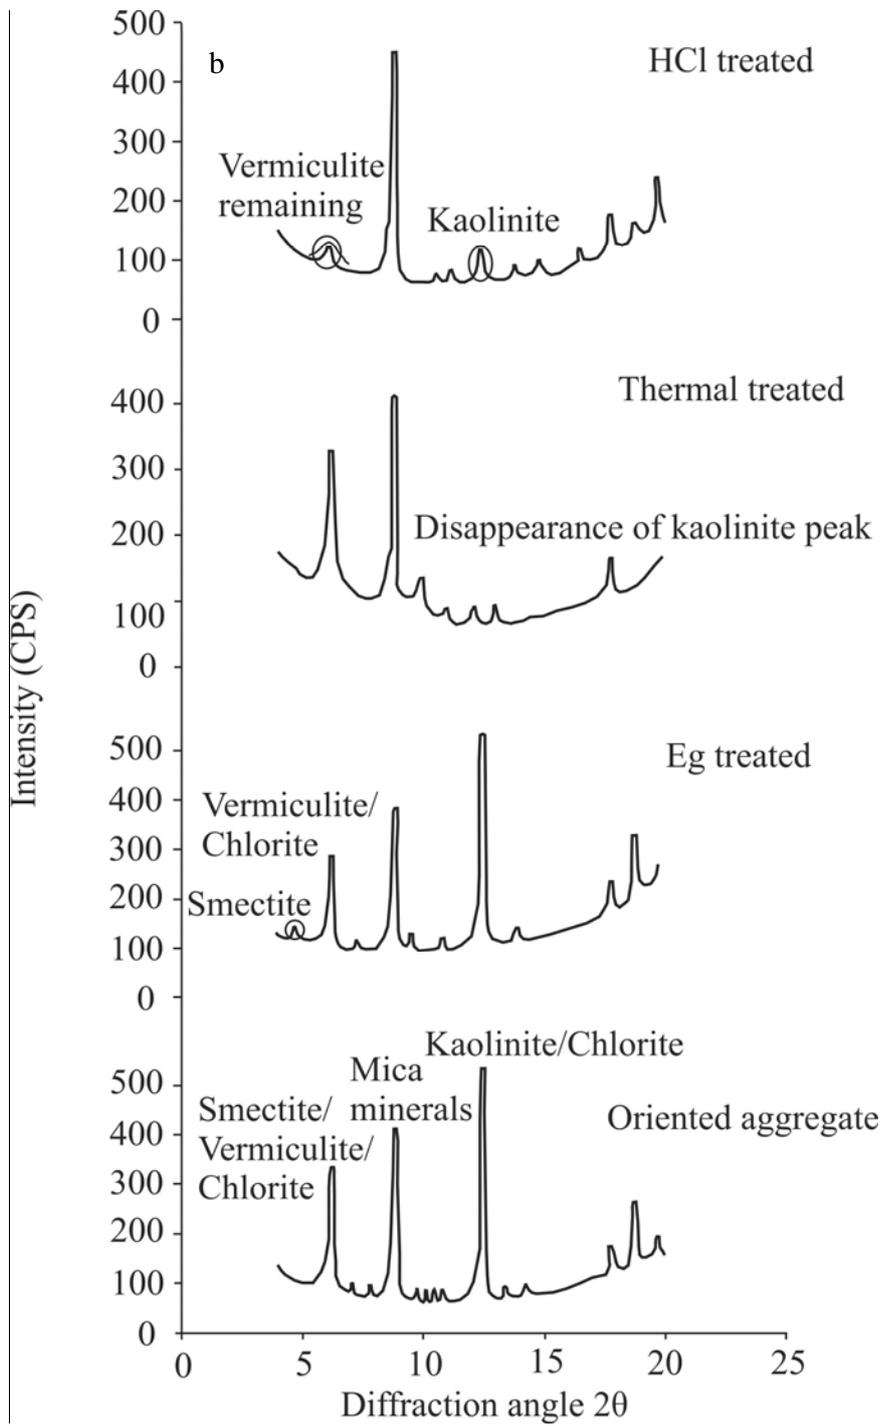
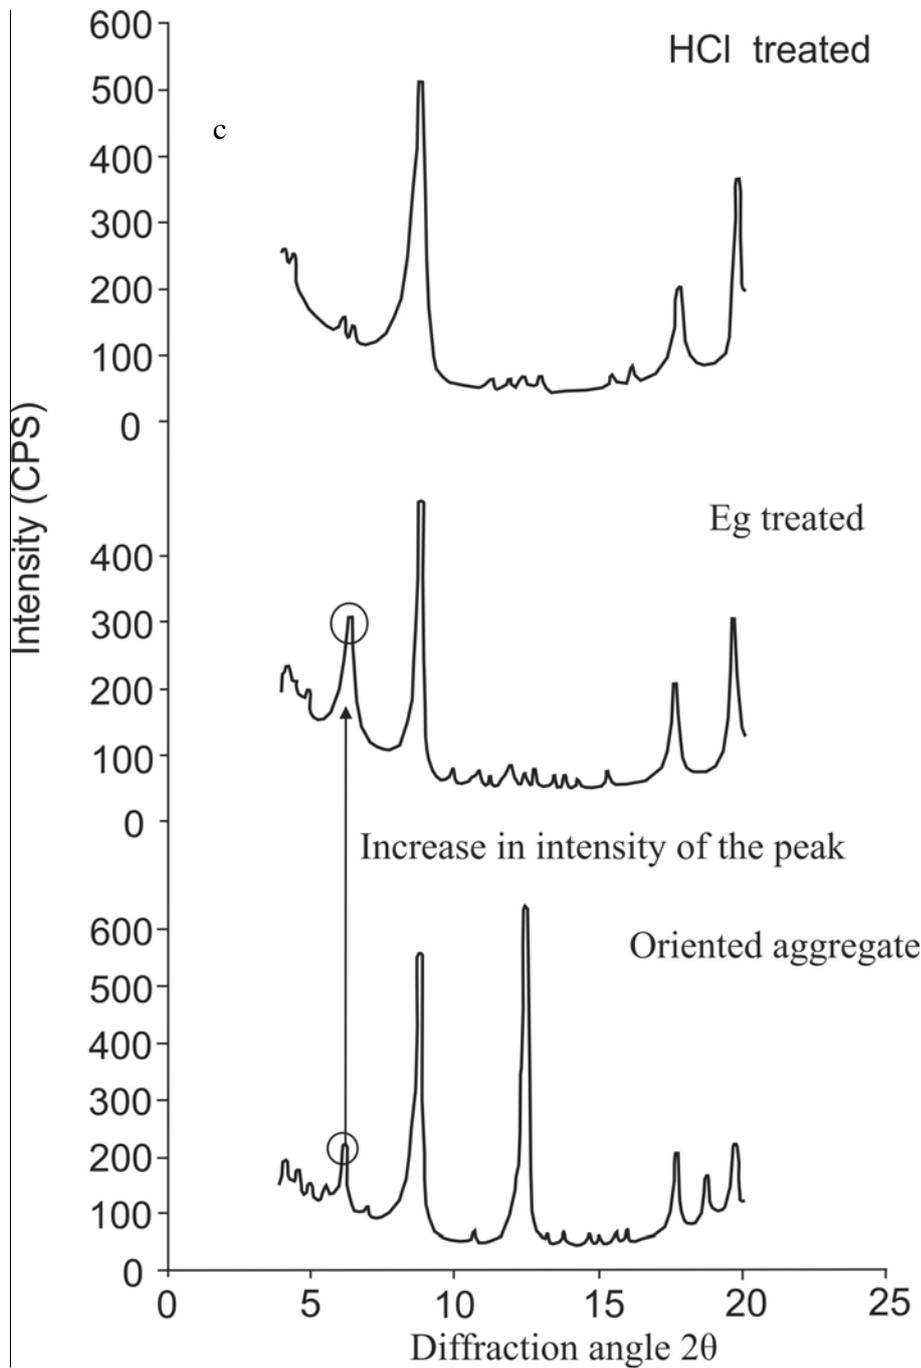
Fig. 10 (a) XRD pattern of the rock sample from Dumre Besi landslide showing the shifting of smectite peak. (b) XRD pattern of rock sample from Ch23.600 landslide, showing the presence of smectite, vermiculite and kaolinite clay minerals. (c) XRD pattern of rocks from Jugadi Khola landslide, showing the weathering of chlorite mineral, here it is seen that the chlorite peak intensity increases due to the EG treatment

show weathering phenomenon with the development of some of clay minerals. Mainly few weathered chlorite as well as original chlorite are the clay minerals observed, while quartz, feldspar, muscovite are the primary minerals. Also, the sandstones are highly fractured and jointed. The rainfall together with the rock structures and river undercutting have acted together to generate this landslide. There is also some role of rock weathering in the formation of this landslide.

This landslide is observed at Ch23.760, and it consists of interbedded quartzite, phyllites and slate of the Nourpul Formation. The quartzite is highly jointed and fractured, and the phyllites are crushed into soils. The XRD analysis of collected rock and soil sample shows that the fresh rocks are rich in quartzite, muscovite, feldspar and chlorite, while

their weathered products are rich in chlorite, smectite, vermiculite and kaolinite. From the analysis, it is seen that rock weathering have a major impact in the formation of this landslide. The weathered rocks with a significant amount of joints and fractures; thick colluvium cover followed by heavy rainfall is responsible for the formation of this landslide.

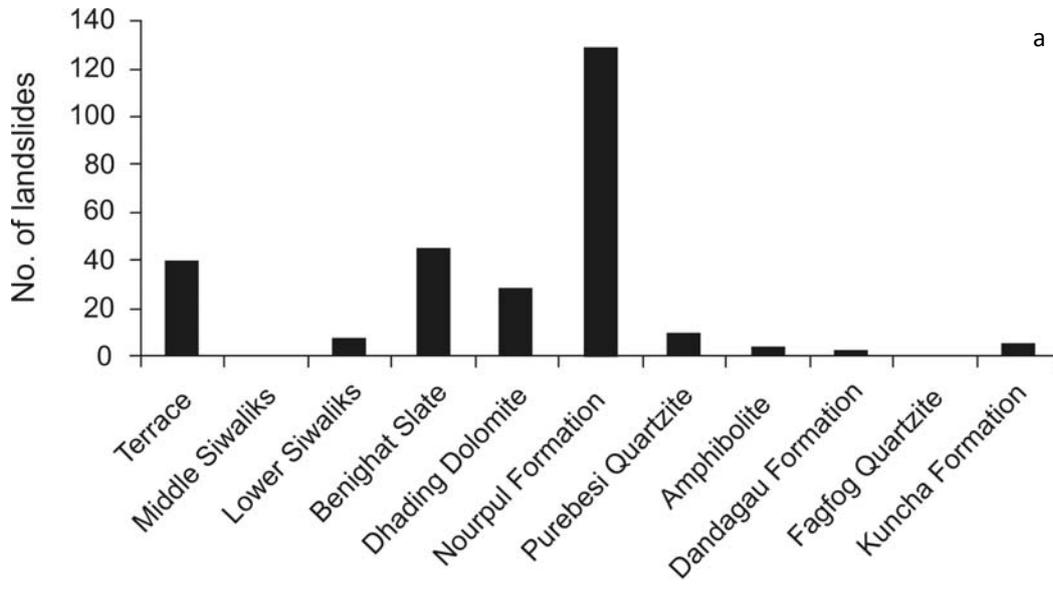
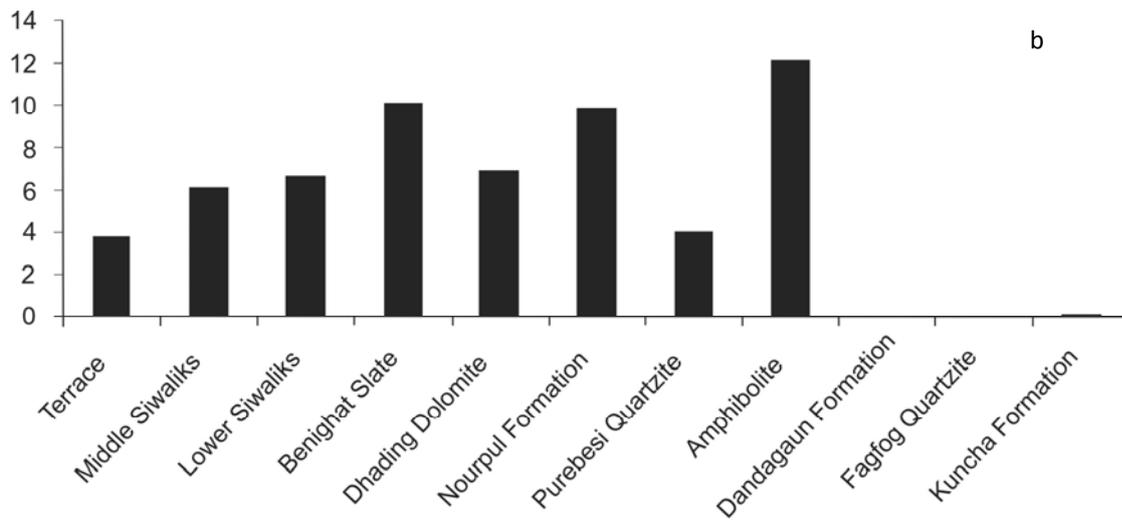
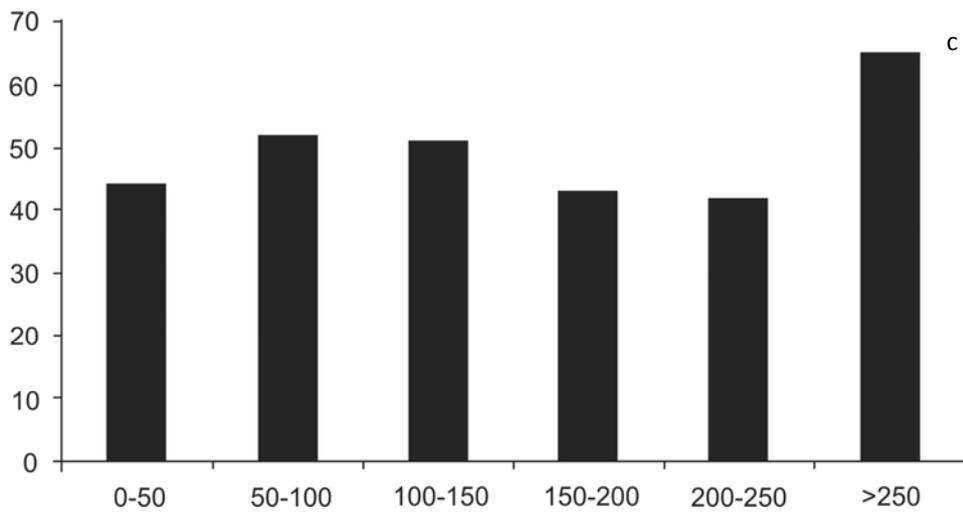
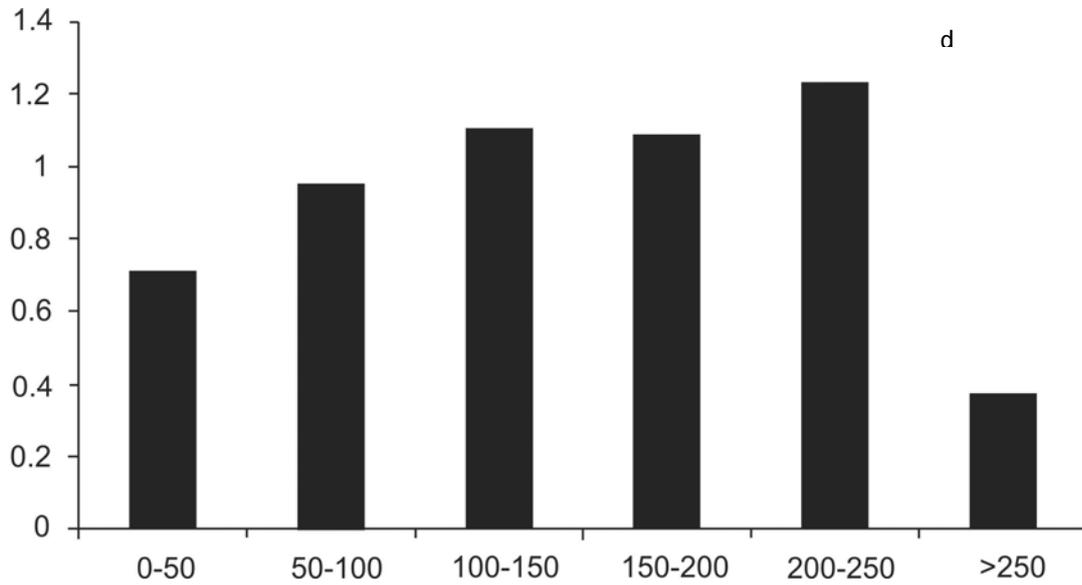
Fig. 11: (a) Distribution of landslides in each lithological unit (b) Landslide density in each lithological unit. (c) Distribution of landslides with the increasing fault distance in Mugling-Narayanghat road corridor and its surrounding area (d) Landslide density in every fault distance zone.

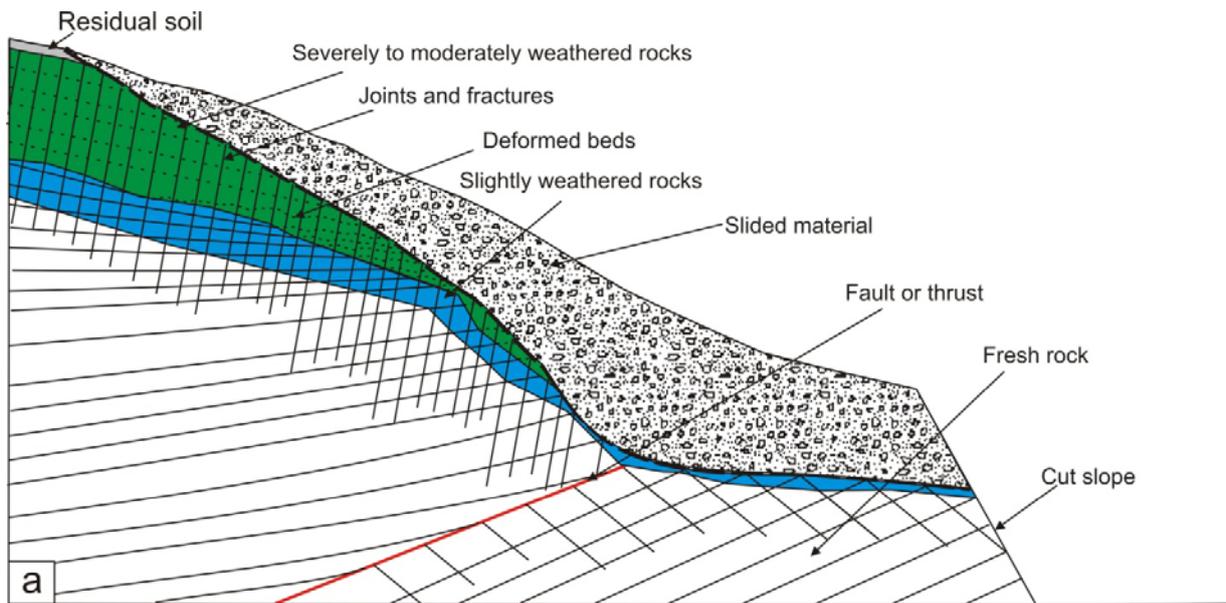
Model showing the development of large complex landslide

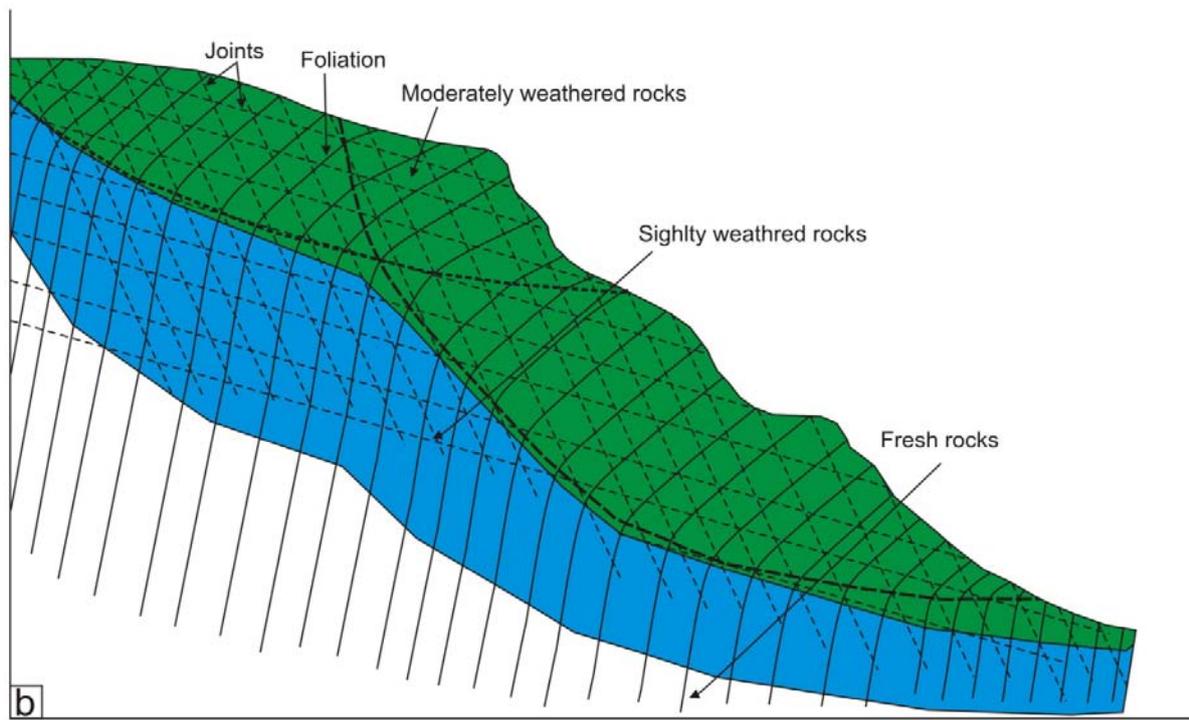
Model showing gravitationally induced complex landslide

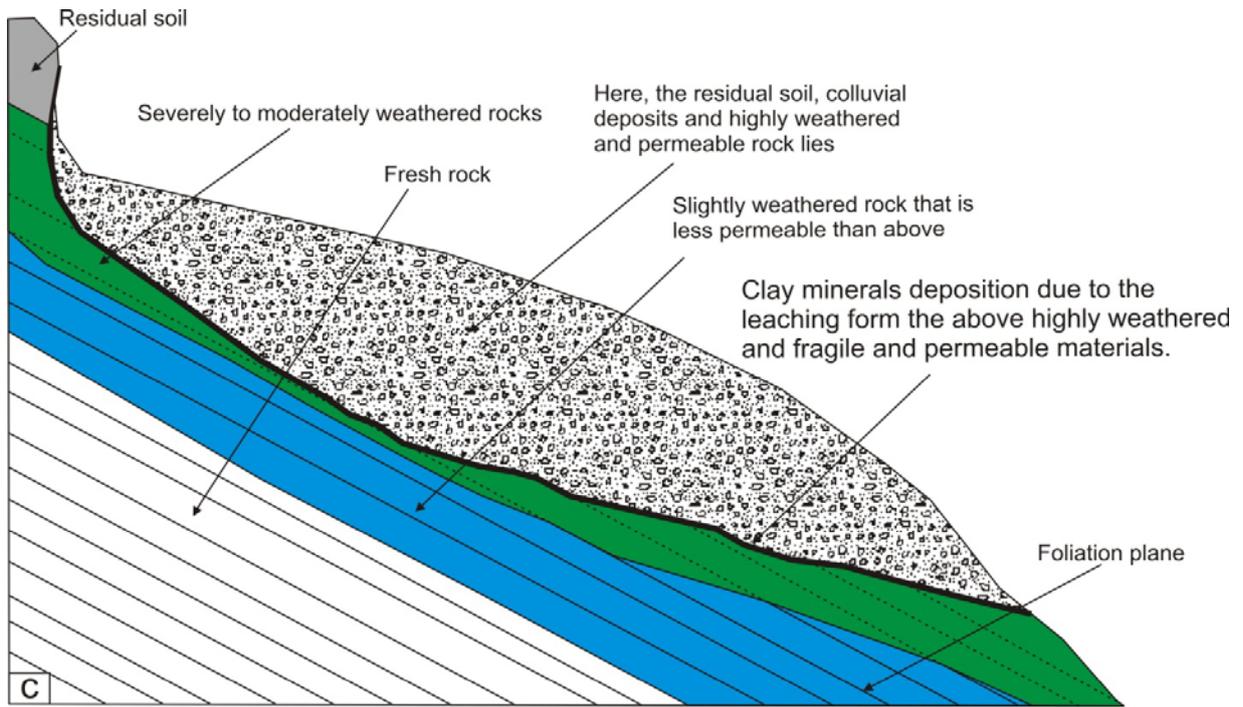
Model showing the development of rotational type of landslide

Several landslides are located at Mugling–Narayanghat road section and its surrounding region. However, some factors like the shape/size, type, material involved are common to all the landslides analysed. Two models can effectively define large and complex landslides. One of them is common in deeply weathered rocks, which are consisting of different lithological units. In addition, geological structures as fault, joints and fractures play a prominent role in creating deep weathering in such landslides (Regmi et al. 2012). The landslide extends up to slightly weathered rocks from completely weathered in these landslide types (Fig. 12a). In the other type of landslides, geological structures as attitude of foliation plane, faults and slope angle have a prominent role, while rock weathering have less effect (Fig. 12b). From Fig. 12c, it is seen that most of the rotational types of landslides are located in the deep slope, where the rock is also

considerably weathered. These types of landslides are mostly found in the slope with uniform lithology. Rock is completely to highly weathered in these landslides (Fig. 12c). Shallow landslides are of two types. One of them is observed in slightly weathered to fresh rocks, where the attitudes of foliation plane and slope angle are very high (Fig. 12d). Several small-scales, very shallow landslides are located in slopes covered by thick colluviums or residual soil. The rock is rather fresh below the colluviums (Fig. 12e). Debris slides and debris flow are the dominant types of landslides occurring in Mugling–Narayanghat road section and its surrounding area. Most part of the area is covered by thick colluviums or residual soils. Rock is also highly weathered below these cover. Thus, in every monsoon, they flow down as debris flow or debris slide. In some case, there is rock fall at the upper slope. The materials from the rock fall get mixed with the colluviums and other materials lying on the slope downhill and flow as debris flow (Fig. 12f). Rock fall is encountered in on steep slopes. The rocks are not much weathered in these steep slopes; however, they are highly jointed and fractured (Fig. 12g).
