The relationship between geology and rock weathering on the rock instability along Mugling-Narayanghat road corridor, Central Nepal Himalaya

Abstract

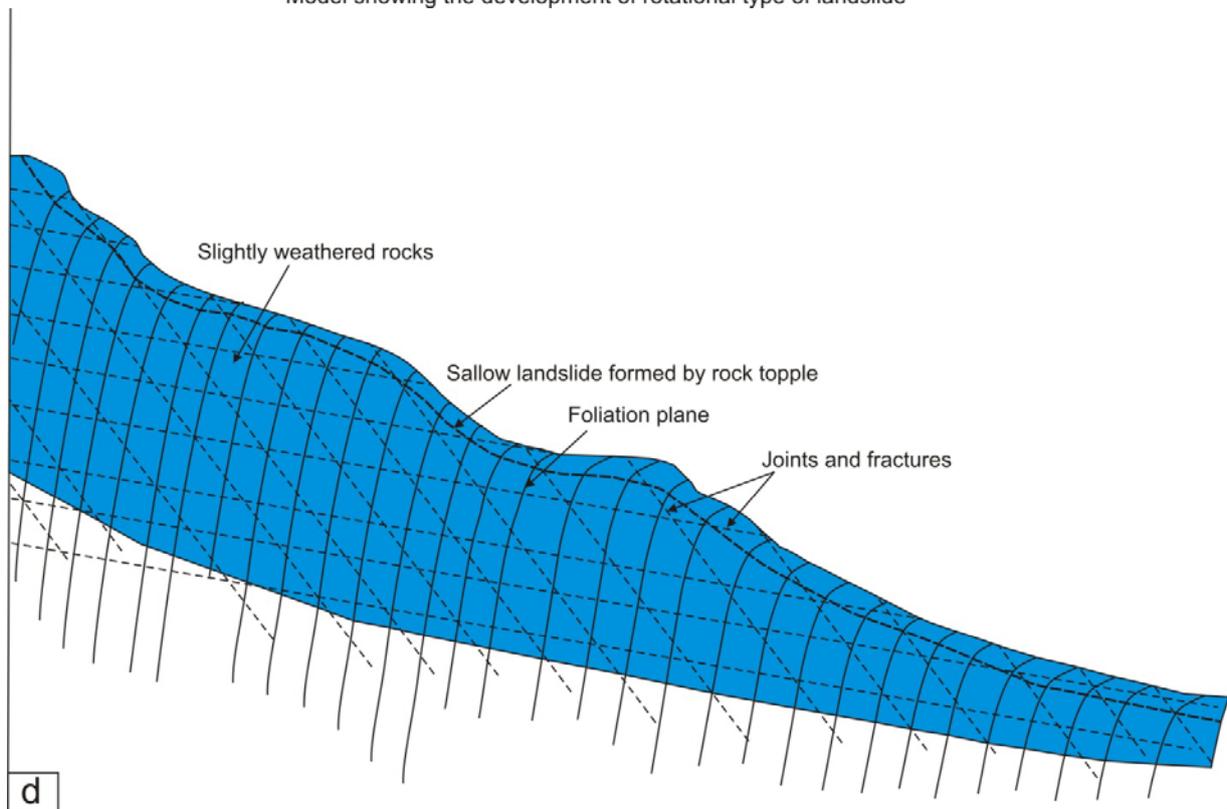
Model showing development of shallow landslide formed by rock toppling

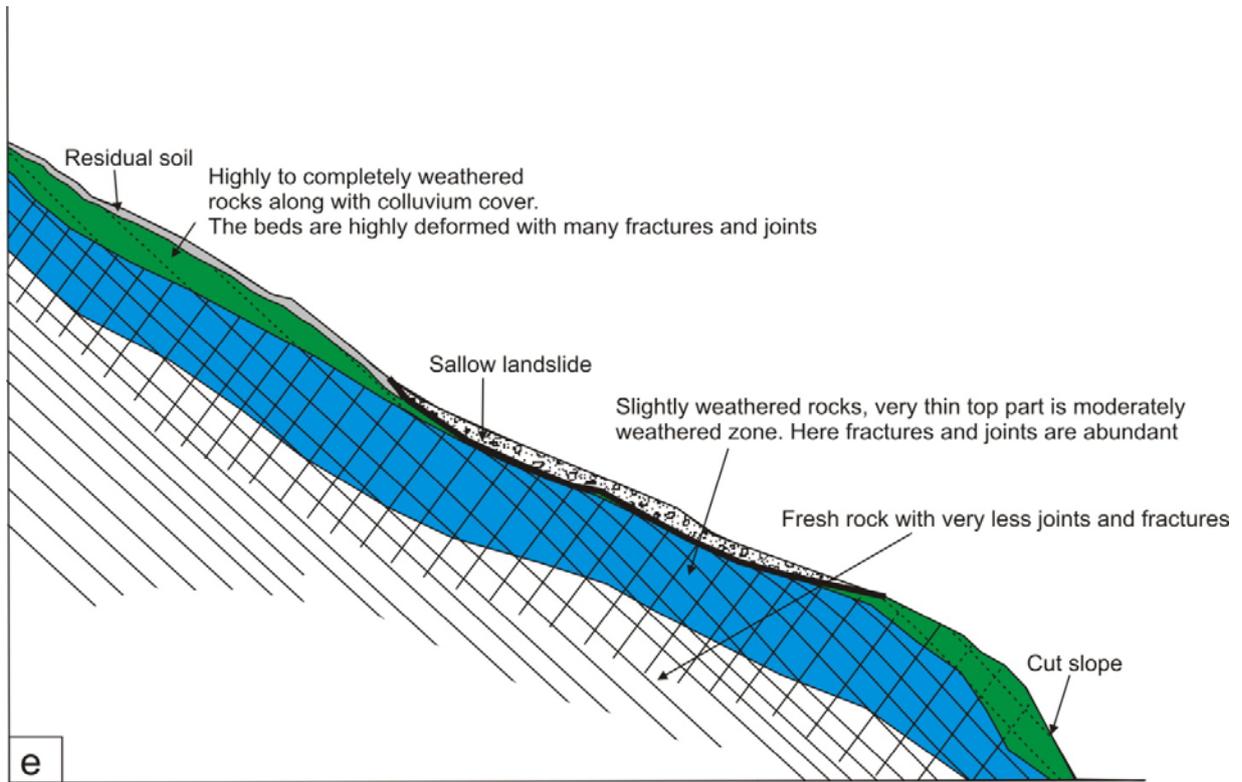
Model showing the development of shallow landslide

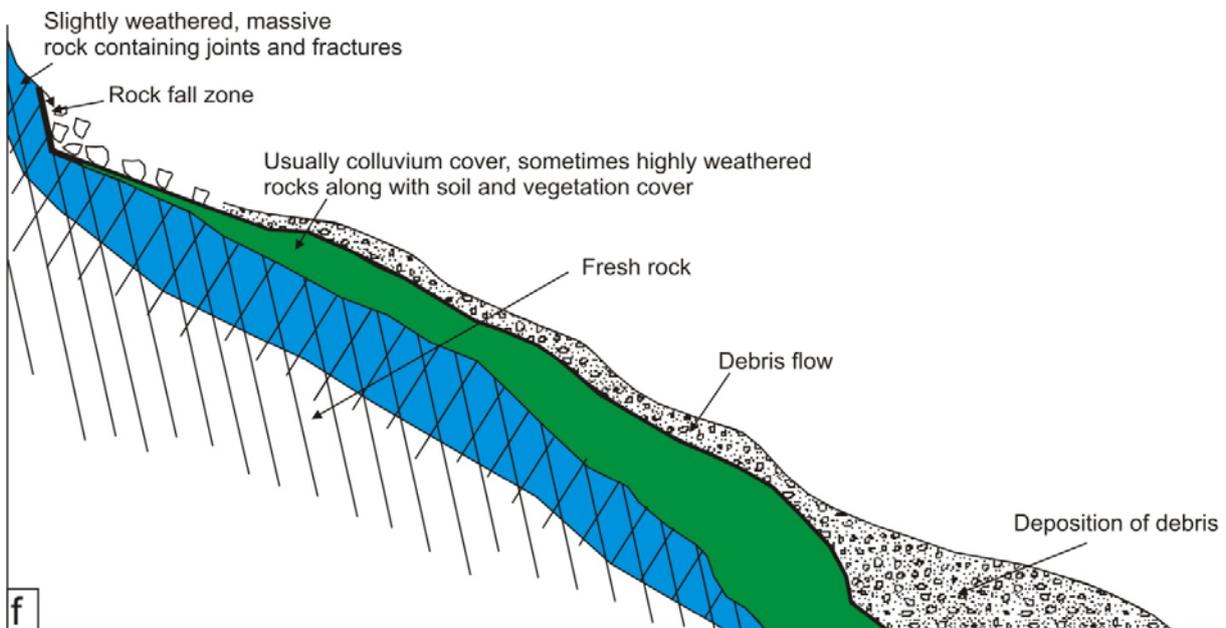
Model showing the development of debris flow, in some cases, except the rock fall at the top part, all other features are similar

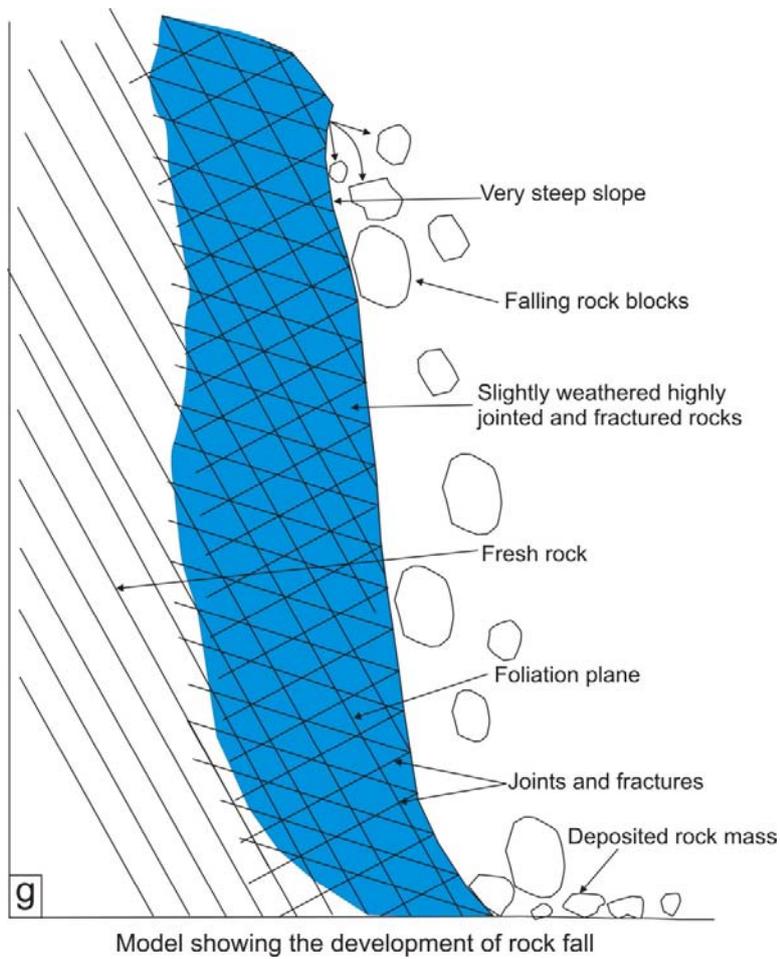
Fig. 12: Models showing different types of landslides occurring at Mugling–Narayanghat road section and its surrounding area and their relationship with general geology and rock weathering (a) Large scale complex landslide, (b) Large and complex landslide formed due to gravitational deformation, (c) Rotational type of landslide, (d) Sallow landslide formed by rock topple, (e) Sallow landslide in colluviums covered slope, (f) Rock fall at the upper slope and debris flow down-slope, and (g) Rock-fall in very steep slope

considerably weathered. These types of landslides are mostly found in the slope with uniform lithology. Rock is completely to highly weathered in these landslides (Fig. 12c). Shallow landslides are of two types. One of them is observed in slightly weathered to fresh rocks, where the attitudes of foliation plane and slope angle are very high (Fig. 12d). Several small-scales, very shallow landslides are located in slopes covered by thick colluviums or residual soil. The rock is rather fresh below the colluviums (Fig. 12e). Debris slides and debris flow are the dominant types of landslides occurring in Mugling–Narayanghat road section and its surrounding area. Most part of the area is covered by thick colluviums or residual soils. Rock is also highly weathered below these cover. Thus, in every monsoon, they flow down as debris flow or debris slide. In some case, there is rock fall at the upper slope. The materials from the rock fall get mixed with the colluviums and other materials lying on the slope downhill and flow as debris flow (Fig. 12f). Rock fall is encountered in on steep slopes. The rocks are not much weathered in these steep slopes; however, they are highly jointed and fractured (Fig. 12g).
